# Intel<sup>®</sup> Pentium<sup>®</sup> III Processor Specification Update

Release Date: August 2007

Document Number: 244453-058

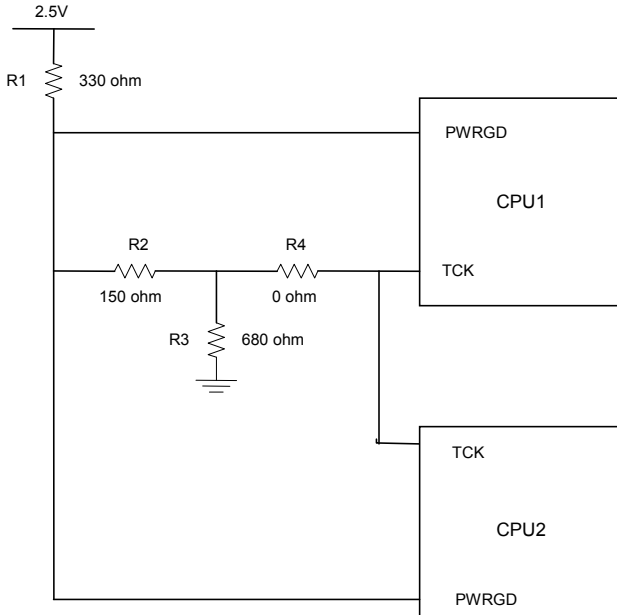
Pentium® III Processor with 512KB L2 Cache Platforms Workaround

Assumes the inputs to the CPU\_PWRGD are open collector signals that are Wire-ANDed together

- The example workaround circuit assumes that the PWRGD inputs into the processors are open collector. Tying the PWRGD inputs together in a Wired-AND fashion allows each processor to receive PWRGD at the same time but at the latter of the 2 separate PWRGD assertions. If separation of the PWRGD inputs to each processor is required, extra circuitry will be required.
