# Intel<sup>®</sup> Pentium<sup>®</sup> III Processor Specification Update

Release Date: August 2007

Document Number: 244453-058

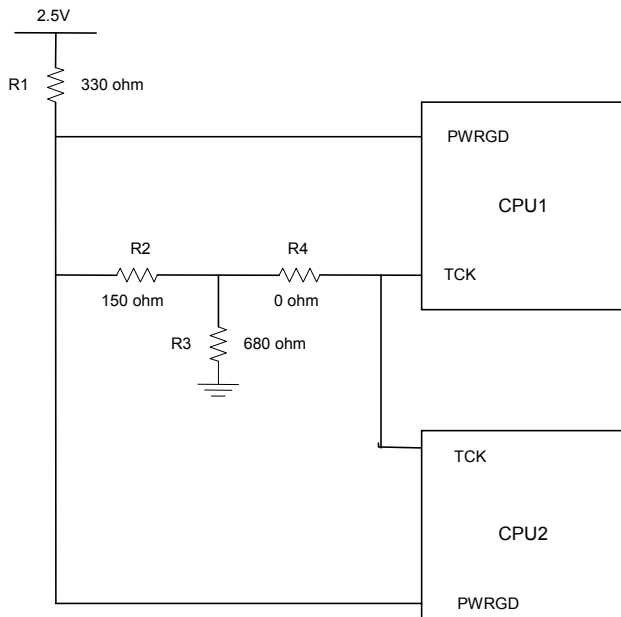
Pentium® III Processor with 512KB L2 Cache Platforms Workaround

In addition, the example workaround circuits shown do not support production baseboard test methodologies that require the use of the processor JTAG/TAP port. Alternative workaround solutions must be found if such test capability is required.

Assumes the inputs to the CPU\_PWRGD are open collector signals that are Wire-ANDed together

- The example workaround circuit assumes that the PWRGD inputs into the processors are open collector. Tying the PWRGD inputs together in a Wired-AND fashion allows each processor to receive PWRGD at the same time but at the latter of the 2 separate PWRGD assertions. If separation of the PWRGD inputs to each processor is required, extra circuitry will be required.
