PanelView 1200 Operator Terminals

2711-KA1, KC1, TA1, TC1, TA4, TC4 Series F

Firmware Release Version 5.10.00, 5.13.00

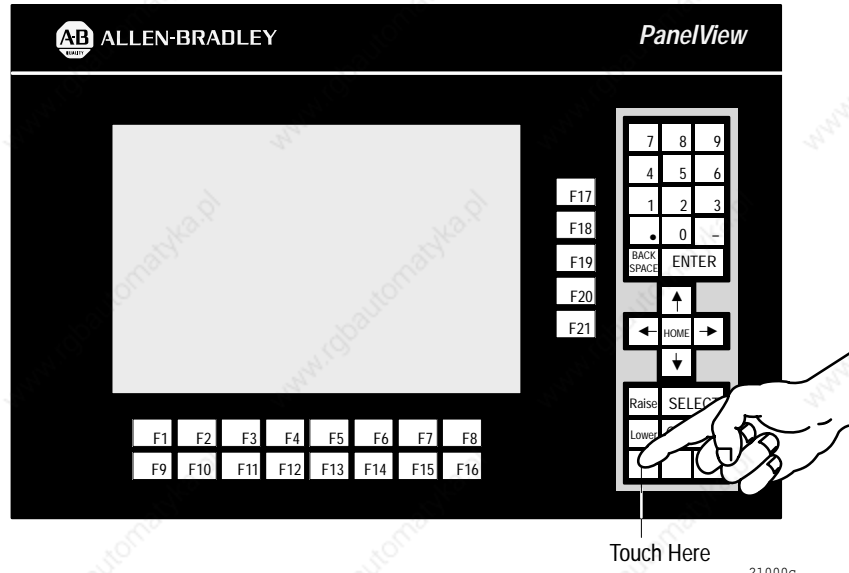
If you installed Touch Screen Firmware on a Keypad Terminal:

- 2 Press the leftmost unmarked gray button (below the Lower button).

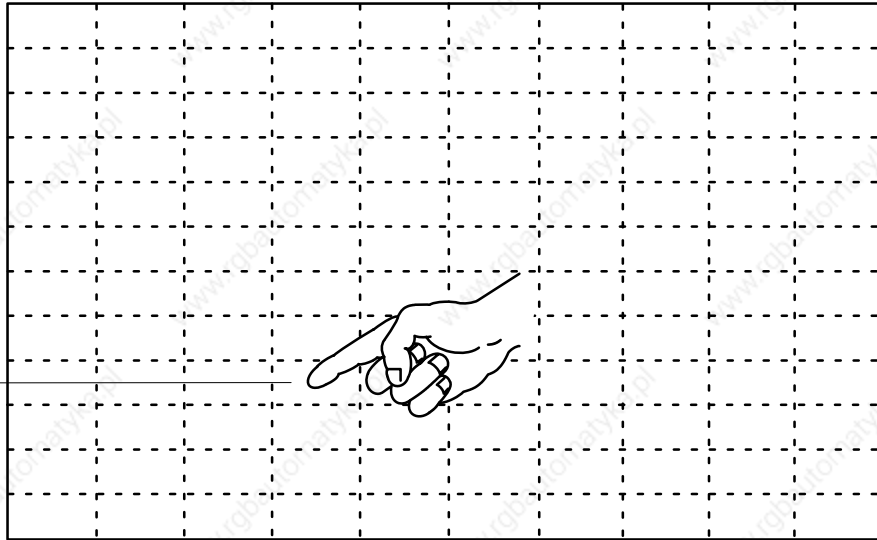
Touch Here
for Column 4, Row 9

If you installed Keypad Firmware on a Touch Screen Terminal:

- If the terminal is powered up in configure mode, press the touch cell at Column 4 and Row 9 (the point of origin is at the top left of the touch screen). This will clear the error message at the bottom of the screen.

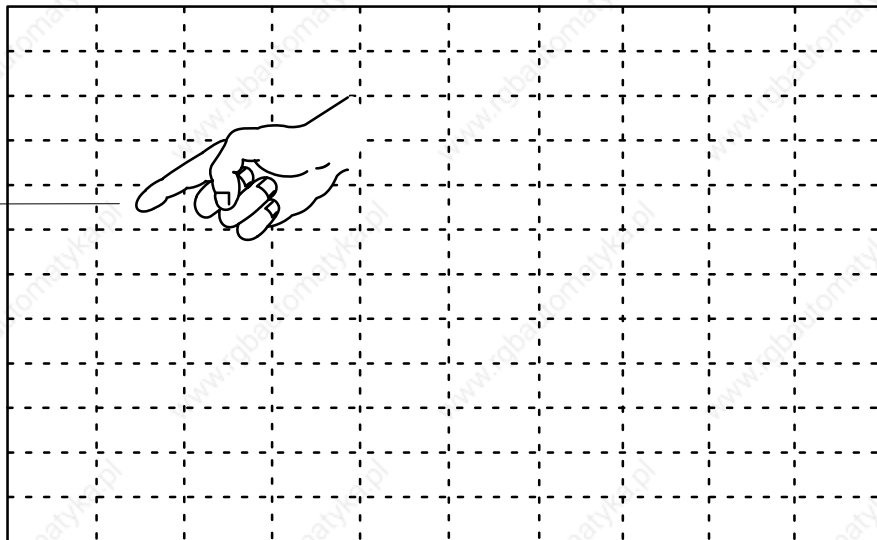
Touch Here
for Column 2, Row 5

2 Press the touch cell at Column 2 and Row 5
