ECODRIVE DKC01.1/DKC11.1 Drive Controllers

Trouble Shooting Guide: ASE 02VRS

DOK-ECODRV-ASE-02VRS**-WAR1-EN-P

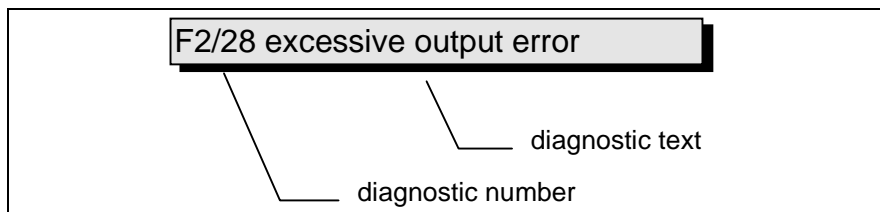
Figure 1-1: Construction of a diagnostic message from a diagnostic number and a diagnostic text.

In the example shown, the "F2" and "28" alternate on the H1 display.

The clear coded text-diagnostic message contains the diagnostic number followed by the diagnostic text; for example, "excessive output error" (Fig 1-1). It can be read from parameter **"S-0-0095, diagnostic message"** and serves the direct display of the process state on a operator surface.

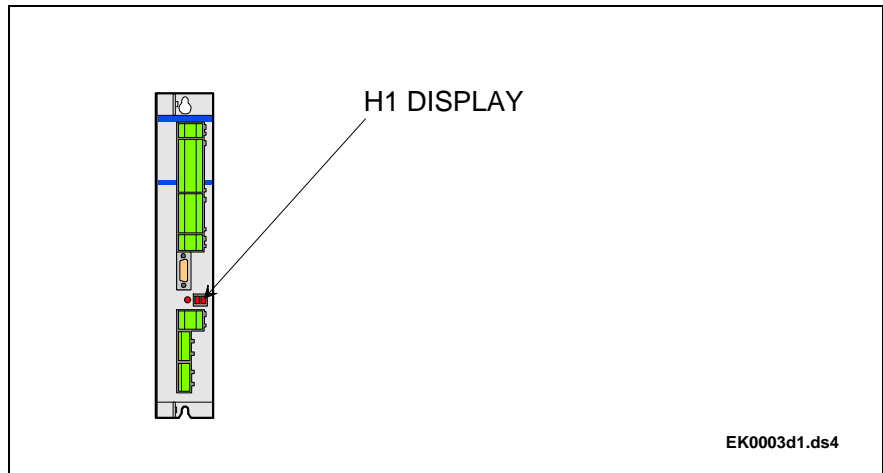
Figure 1-2: H1-Display

The symbolized diagnostic number appears on this two-positional-seven-segment display. The form of the display is seen on the diagram "Priority dependent diagnostic message diagram."

The H1 condition display on the front side of the DKC gives information about:

- Operating condition of the drive controller
- Drive controller or cable malfunctions
- Motor malfunctions
- Malfunctions caused by invalid parameter input
- Application errors

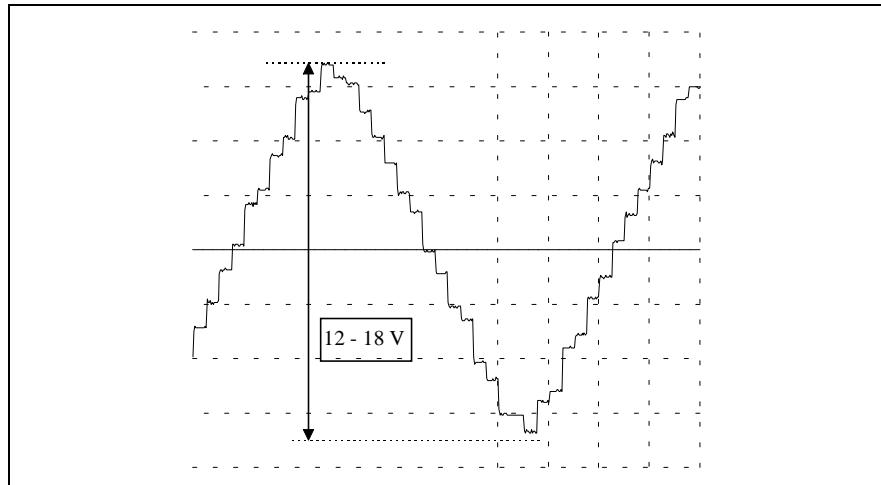
Figure 2-1: Methodically measured signal amplitude over AK: X31/1-2

F822 Motor Encoder Failure: Signal too Small

1. Defective feedback cable.
2. Defective feedback.

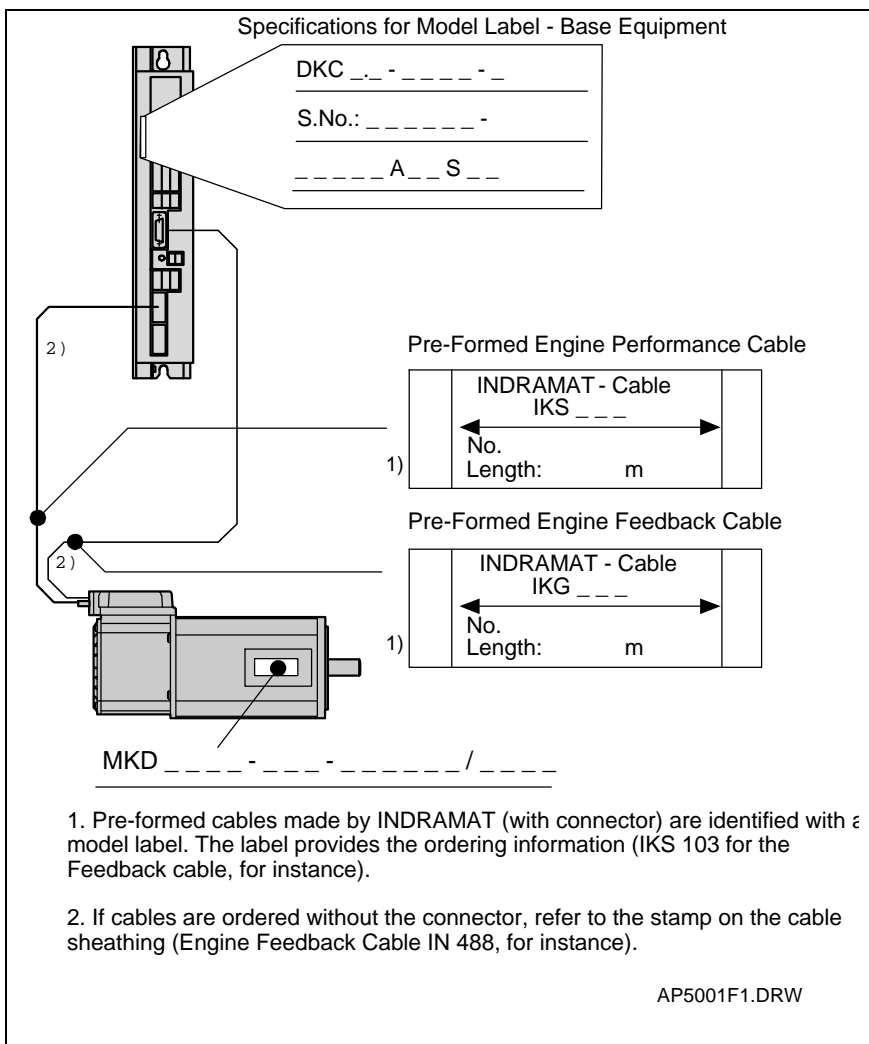
Figure 4-1: Type Description of the Drive Components

The identification plate for MKD motors is on the right side of the motor (when looking at the motor shaft with the motor connection box on top).

Assembled cables are supplied with a label (cable mark) that carries the cable number and the length of the assembled cable.

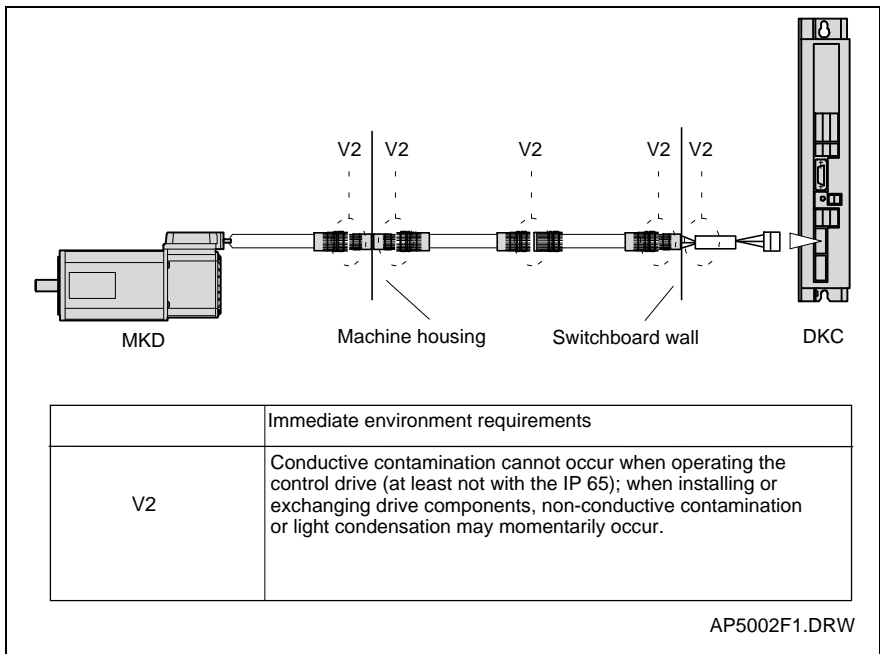
Figure 4-2: Contamination level according to DIN VDE 0160

Note: When the cables are exchanged, open connectors from power connections should be closed with protection covers to protect against the spread of coolant, lubricating fluid or dirt (adm. protection level V2).
