ECODRIVE DKC01.1/DKC11.1 Drive Controllers

Trouble Shooting Guide: ASE 02VRS

DOK-ECODRV-ASE-02VRS**-WAR1-EN-P

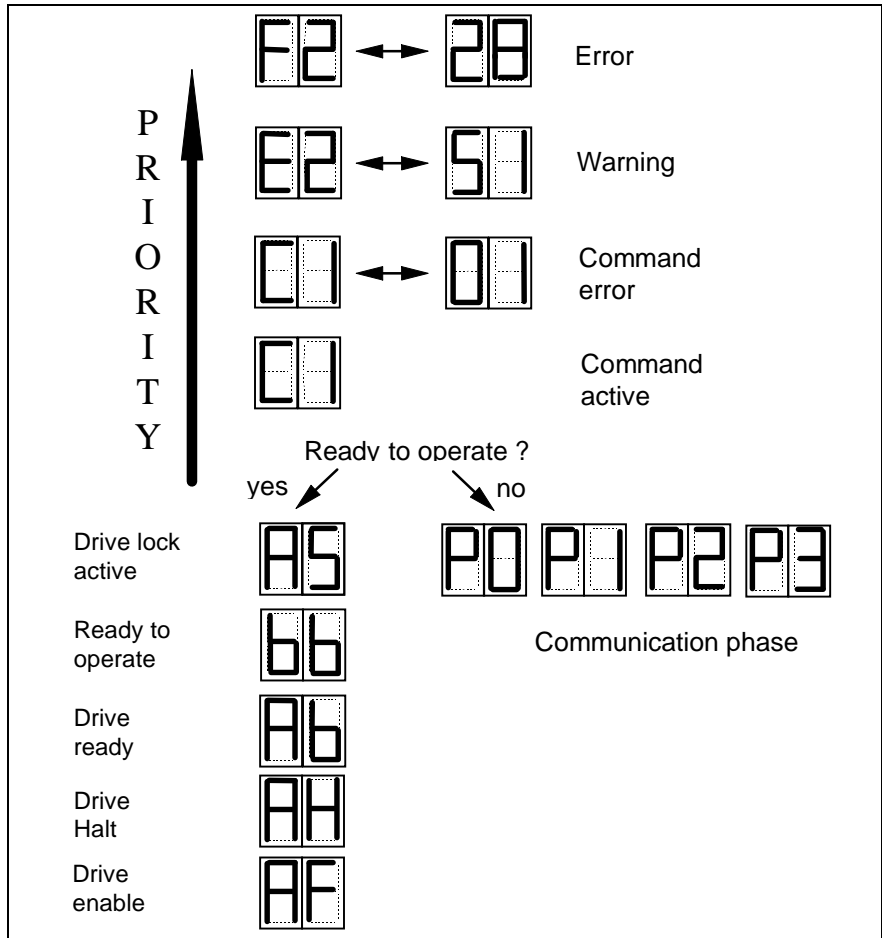
If more than one diagnostic message is generated at the same point within the string, the diagnostic with the highest priority will be displayed first.

The following graphic shows the order of priority.

Figure 1-3: Priority dependent diagnostic message diagram

The symbolized diagnostic number appears on this two-positional-seven-segment display. The form of the display is seen on the diagram "Priority dependent diagnostic message diagram."

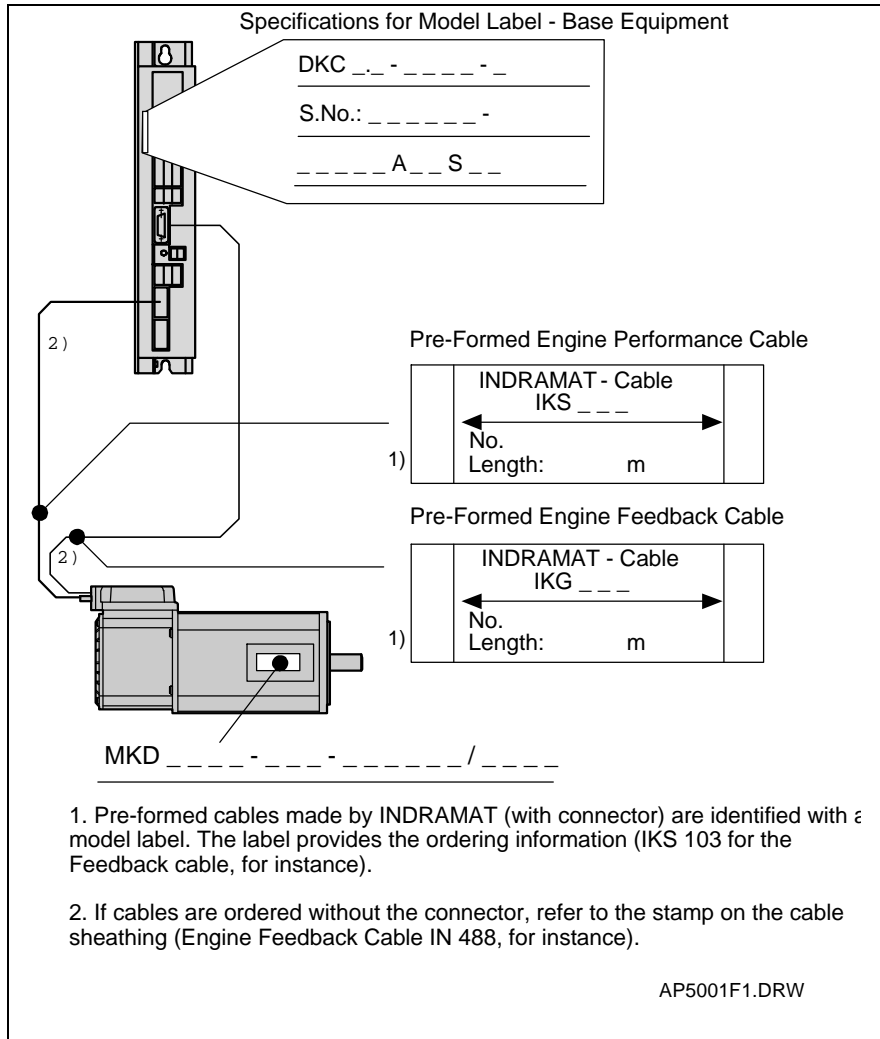
The identification plate for MKD motors is on the right side of the motor (when looking at the motor shaft with the motor connection box on top).

Assembled cables are supplied with a label (cable mark) that carries the cable number and the length of the assembled cable.

Figure 4-1: Type Description of the Drive Components
