PanelView 1200 Operator Terminals

2711-KA1, KC1, TA1, TC1, TA4, TC4 Series F

Firmware Release Version 5.10.00, 5.13.00

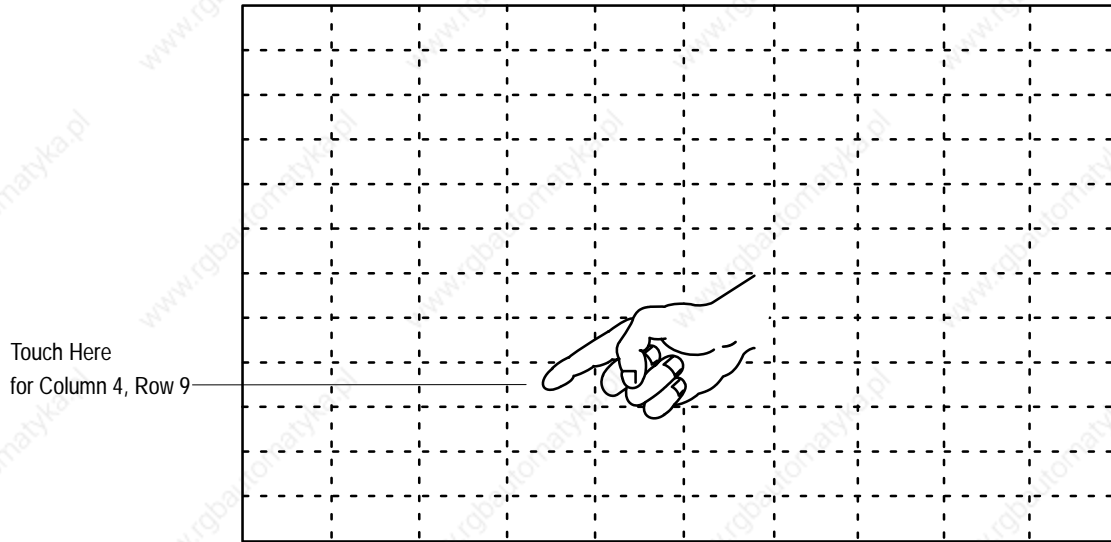
- If the terminal is powered up in configure mode, press the touch cell at Column 4 and Row 9 (the point of origin is at the top left of the touch screen). This will clear the error message at the bottom of the screen.

2 Press the touch cell at Column 2 and Row 5
