## PanelView 1200 Operator Terminals

2711-KA1, KC1, TA1, TC1, TA4, TC4 Series F

Firmware Release Version 5.10.00, 5.13.00

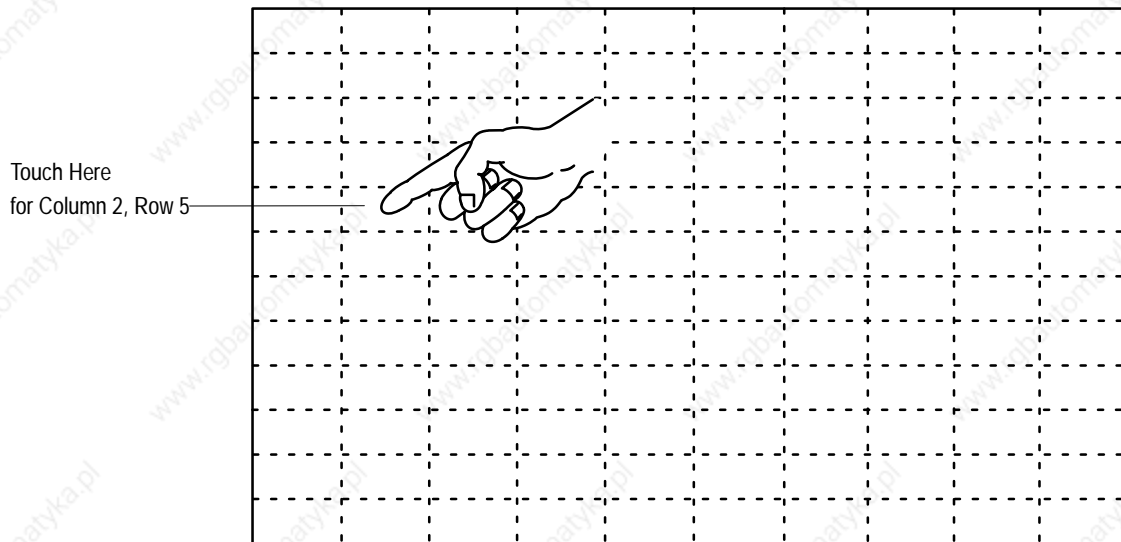
**2 Press the touch cell at Column 2 and Row 5**
